PENJAJAWOC STREAM ANALYSIS AND INTERPRETATION

(FINAL REPORT)

Report to: Maine Department of Environmental Protection
Bureau of Land and Water Quality – Division of Watershed Management
17 State House Station
Augusta, Maine 04333-0017

Date: June 2006

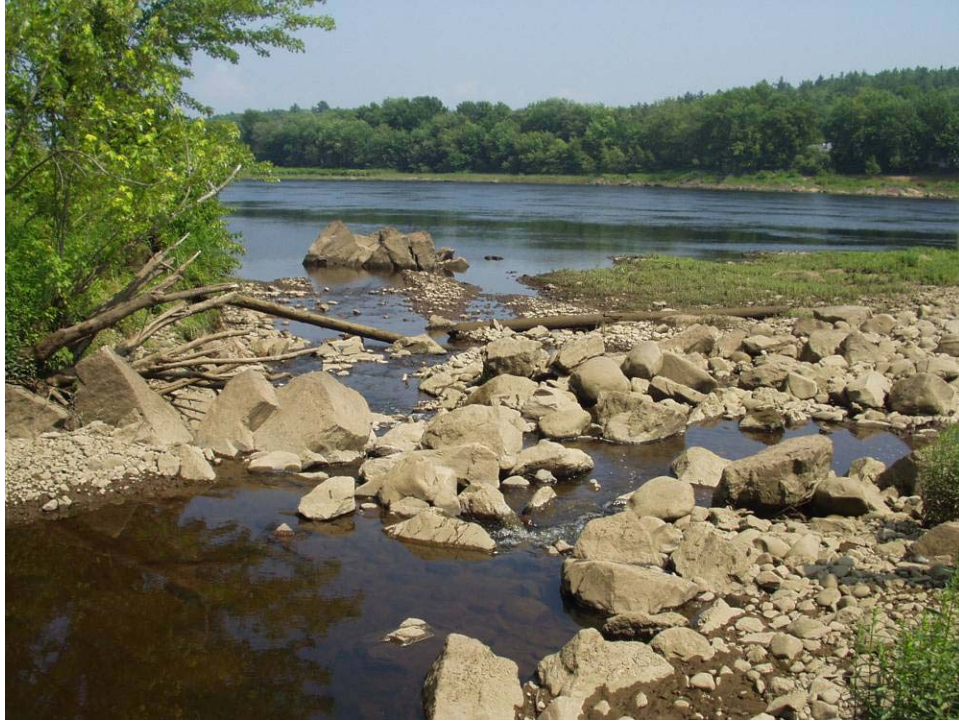
During the field surveys, the shell of a rare species of freshwater mussel, the yellow lampmussel (*Lampsilis cariosa*) was found at the confluence of Penjawoc Stream with the Penobscot River (**Photo 1**). The yellow lampmussel is a threatened species under the Maine Endangered Species Act. Although yellow lampmussels are usually found in medium to large rivers, their host fish species are white perch (*Morone americana*) and yellow perch (*Perca flavescens*), two species without strong swimming or leaping abilities who could easily be blocked by barriers at crossings. (All freshwater mussels rely on host aquatic species, typically fish, for the development of mussel larvae into subadults; larvae live on the host's gills for weeks or months before dropping off as tiny mussels.) Although it is unknown if

Photo 1. Mouth of Penjajawoc Stream looking downstream towards Penobscot River (July 19, 2005).

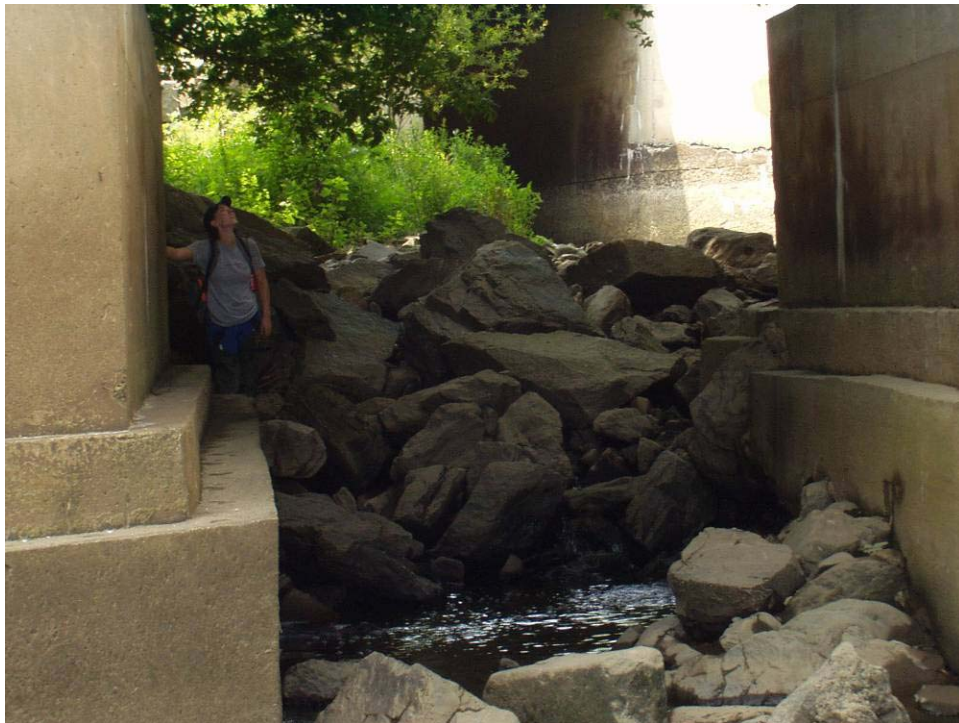
The first potential barrier upstream of the Penobscot River is at the railroad trestle (**Photo 2**), where there is a steep drop comprised of large boulders. At least part of the trestle abutments may be founded on an outcropping of bedrock, perhaps indicating that a natural falls may have existed historically at the site. Despite its geology, upstream passage for aquatic organisms is not only challenged by the steepness of the drop but the width of the trestle opening. The width of the opening is much less than bankfull for the stream, and there is considerable streamflow passing underneath the abutments rather than in the channel (**Photo 3**). Penjajawoc Stream is of interest to the Maine Atlantic Salmon Commission (MASC) because it may serve as temperature refugia for adult Atlantic salmon (*Salmo salar*) in the Penobscot River (Joan Trial, MASC, personal communication). The abruptness of the drop, and lack of a well defined channel, may even pose a passage problem for a very strong swimmer and leaper such as an Atlantic salmon. Another anadromous (i.e., sea run) fish species that could potentially access habitat in Penjajawoc Stream is the blueback herring (*Alosa aestivalis*), which swims upstream from the Atlantic to spawn in freshwater riffles in the spring. The railroad crossing would definitely be a barrier to blueback herring, which are considered strong swimmers but have little leaping ability.

Photo 2. Penjajawoc Stream at railroad trestle near mouth (July 19, 2005).

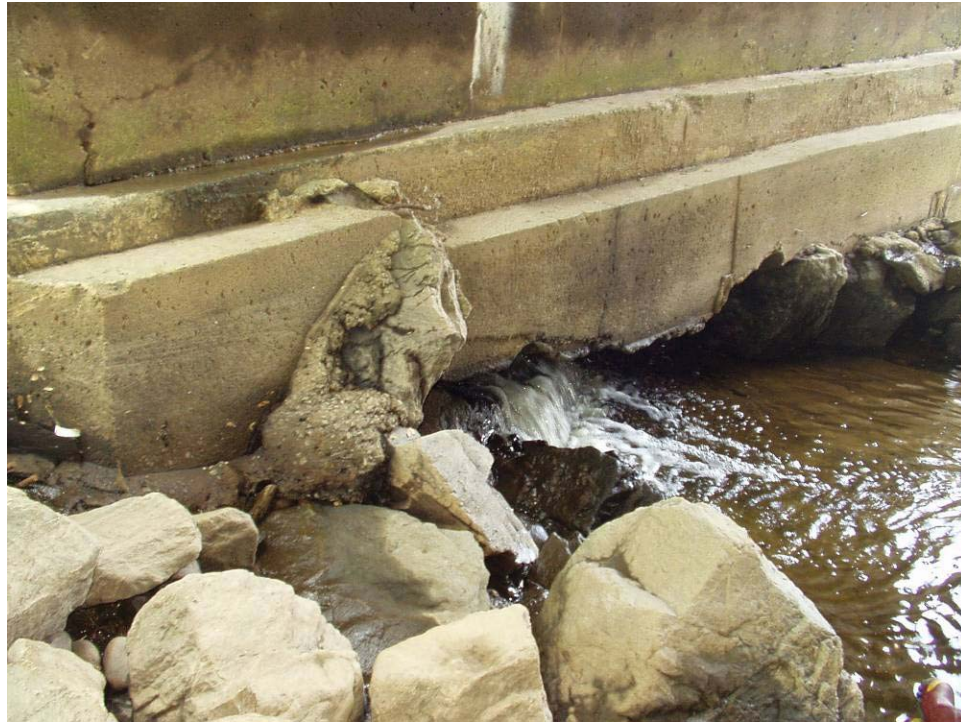
Photo 3. Penjajawoc Stream at railroad trestle showing streamflow under abutment (July 19, 2005).

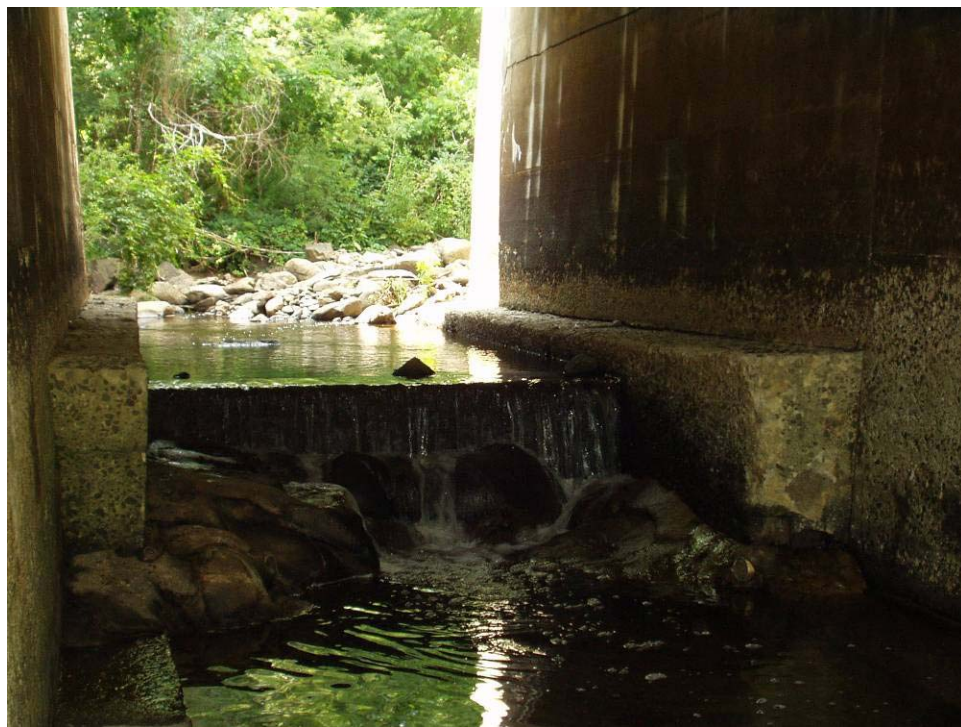
Photo 4. Penjajawoc Stream looking upstream through Route 2 crossing (July 19, 2005).

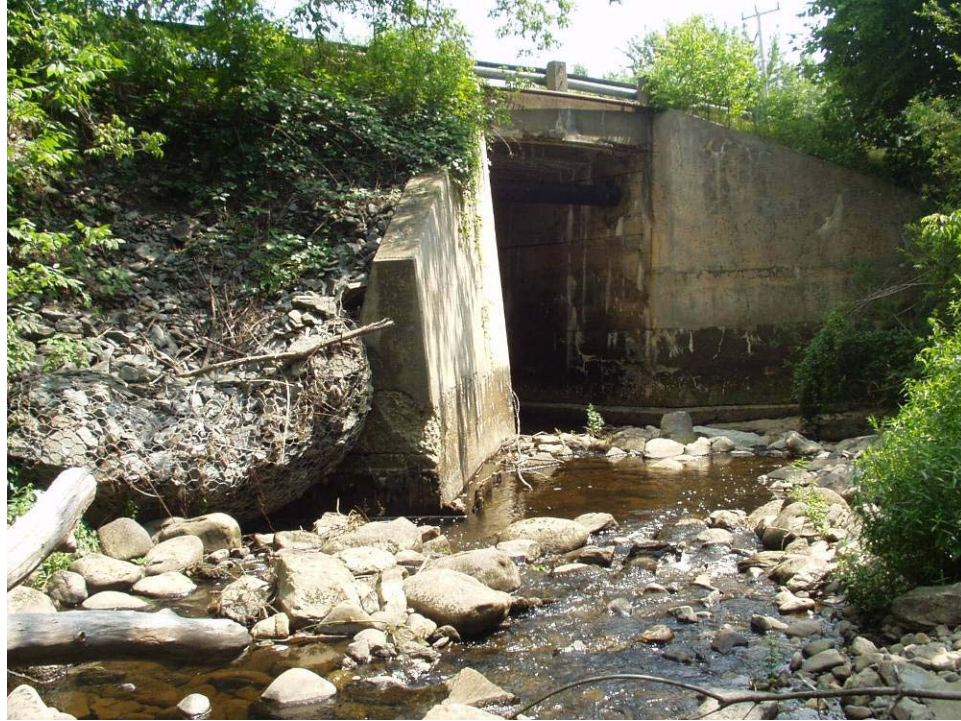
gabions on the upstream side of Route 2 (**Photo 5**). The poor condition of the crossing may eventually provide an opportunity to replace the structure or retrofit it with better passage.

Photo 5. Penjajawoc Stream looking downstream towards Route 2 crossing; note slumped gabions on left (July 19, 2005).

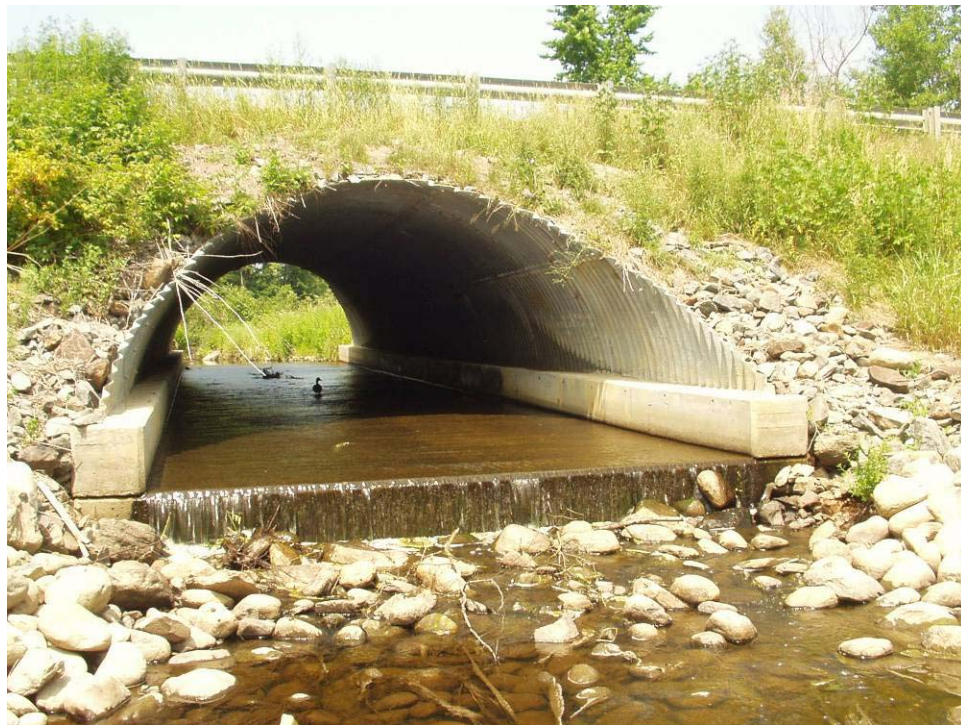
Photo 6. Penjajawoc Stream looking upstream towards Mount Hope Avenue crossing (July 19, 2005).

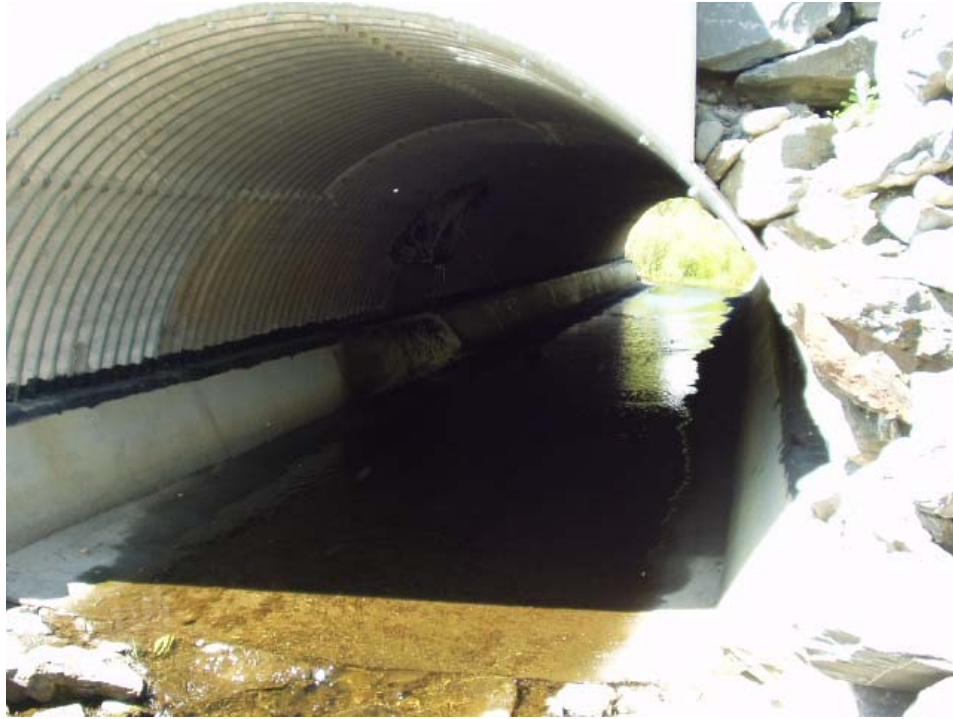
The biggest issue for the Stillwater Avenue crossing is whether further development in the area will create a passage barrier. Although there is not an obvious scour pool downstream of the culvert, urbanization in the watershed upstream of Stillwater Avenue could increase peak flows at the crossing, creating a scour pool and bed degradation. The crossing is most illustrative, however, of the issue of culvert *length*. Many aquatic species, such as fish, can sustain “burst” or “darting” speeds for short periods of time. Although these species might be able to negotiate the culvert at its current length, the crossing may become impassable if the culvert is lengthened. This may be a concern, given that strategic planning for the mall area suggests that Stillwater Avenue may eventually be widened, which would either require a

Photo 7. Penjajawoc Stream looking upstream through Stillwater Avenue culvert (August 23, 2005).

longer culvert or two long culverts in series. Throughout the watershed, it is recommended that new stream crossings, or stream crossings that are lengthened, are designed to protect passage for aquatic organisms.
